***WILLOW CREEK STATE RECREATION AREA
RIVER ACCESS STUDY***

Final Report

**Alaska Department of Natural Resources
Division of Parks and Outdoor Recreation
550 W 7th Ave, Suite 1380
Anchorage, AK 99501-3561**

**HDR Alaska, Inc.
2525 C Street, Suite 305
Anchorage, Alaska 99503**

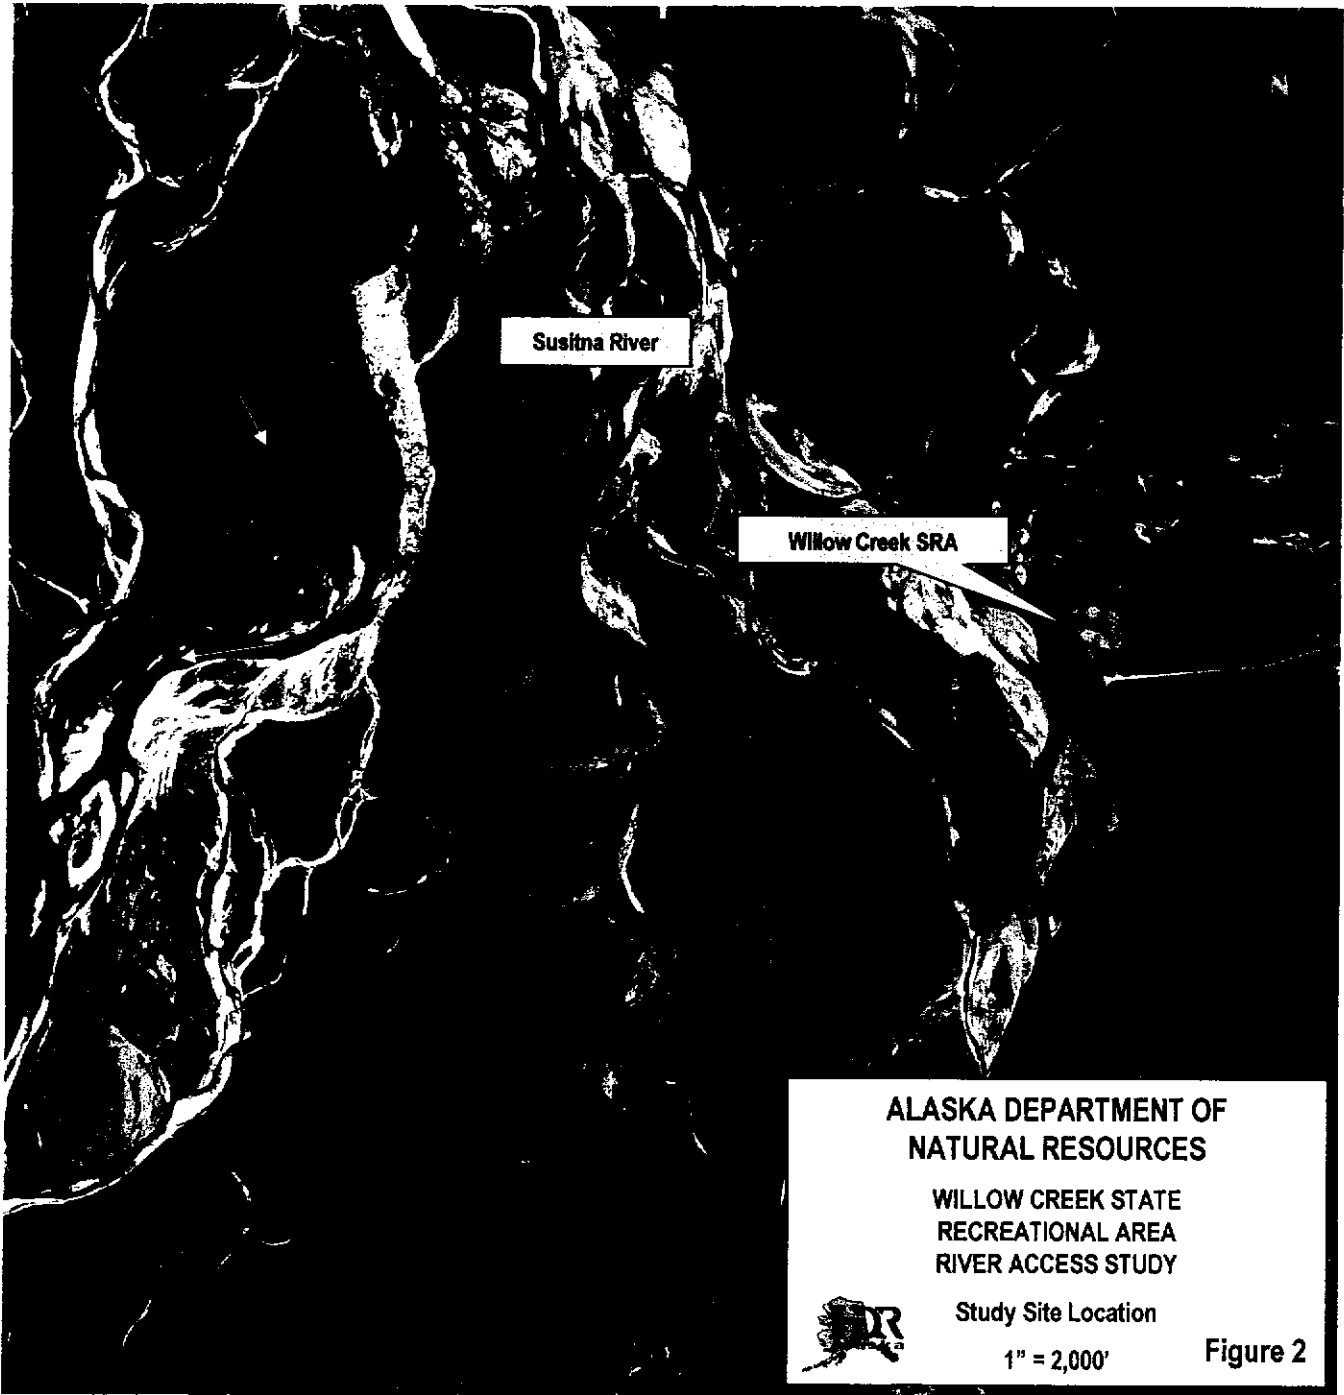
Figure 2

Study Site Location

1" = 2,000'

See Figures 1, 2 and 3 for a vicinity map and aerial photos of the study area. Additional ground photos are included in Appendix 1 along with an oblique aerial of the site. The river miles (RM) used in this report are the same as were used in the 1997 and 2000 DSF reports. River mile zero is approximately at the confluence of the Susitna River and Cook Inlet.

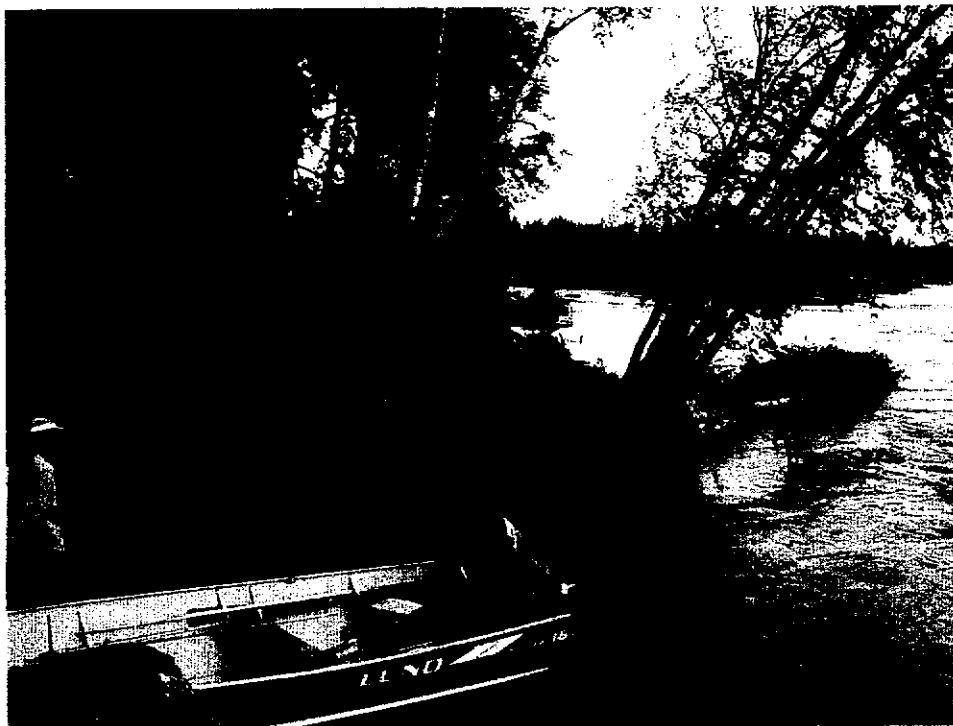
8/3/06 - Ramp location, looking downstream.

Immediately downstream of this site is the entrance to a river side channel. This entrance was blocked with snags and presents an immediate danger for boaters exiting or entering this site. These snags will need to be cleared as part of maintenance for this site. At the time of the reconnaissance this side channel was too shallow for boating.

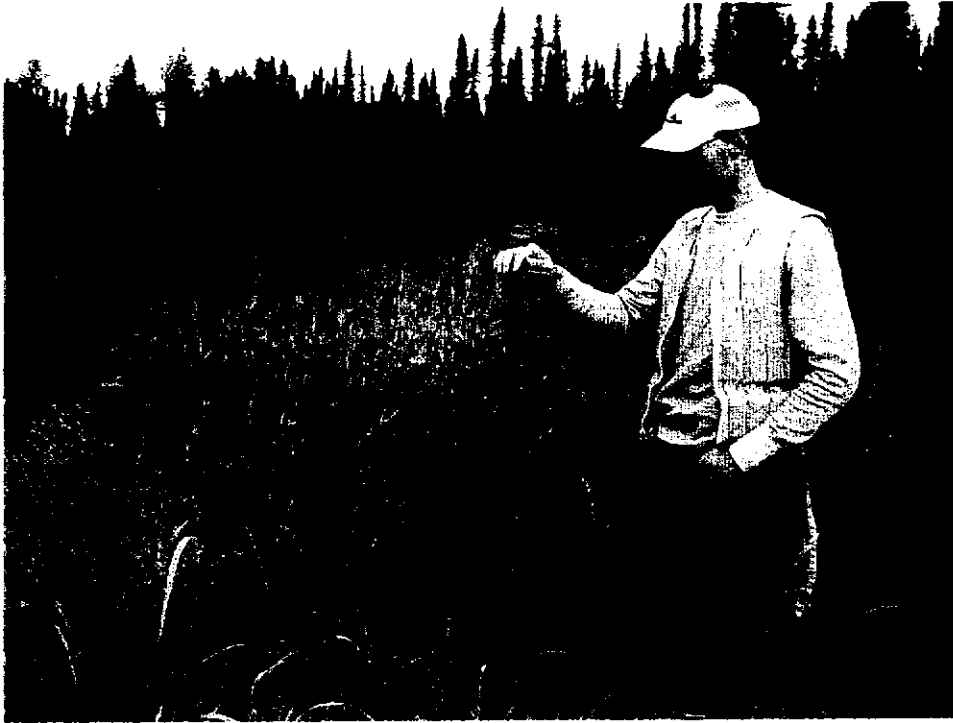
8/3/06 - Typical shrub wetland at parking area.

Inland of the evaluated launch site to about the existing entrance station, the soils are classified by the Soil Survey of Matanuska Susitna Valley Area (SCS, 1995) as Killey-Moose River Complex. The Killey-Moose River Complex is described as 3 to 60 inches of stratified silty sandy sediment over gravelly sand. Further inland the SCS classifies the soil as Salamatoff Peat which is described as very poorly drained peat soils with up to 5 feet of peat overlying unknown soils. Soil probing done in 2006 in the Killey-Moose River Complex soil type in this area penetrated 2 to 3 feet before encountering solid material. Soil probing done in 2006 in the Salamatoff Peat soil type in this area penetrated 5 feet before encountering solid material.

The vegetation in the silty soils consists of paper birch, white spruce, cottonwood and native grasses. Vegetation in the peat areas consists of black spruce, ericaceous shrub scrub and sedge-shrub bog meadow and fen meadow.

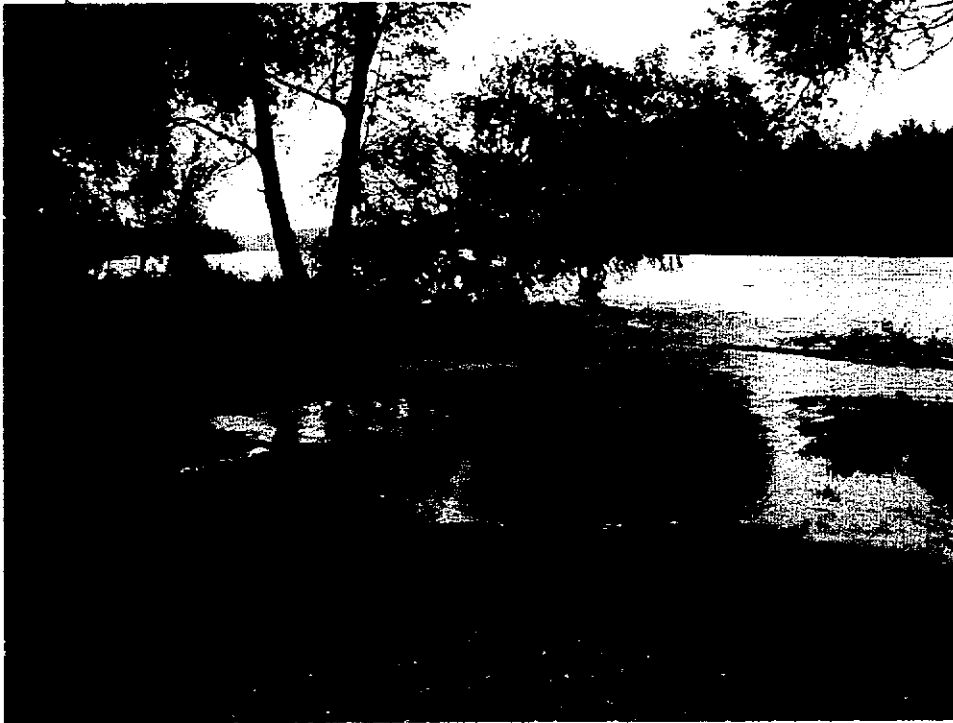
8/20/06 - Ramp Site, during August 2006 high water.

Additional site reconnaissance was done following a flood event that began on August 18, 2006. This was a large event on Willow Creek (peak flow of 7970 cfs at Willow Creek near Willow and estimated return interval in excess of 100 years) and a moderate event on the Susitna River (estimated return interval of 5 to 10 years). At the peak of the flood, the Susitna River was slightly over the top of its banks. The ramp site was inspected on August 30, 2006, as the flood was in recession. Approximately 5 to 10 feet of bank was lost in the proposed ramp area and the cut in the bank was filled in with silts and sands to a level 2 feet below the top of the bank.
